## Chapter 3

# PERFORATING MACHINES

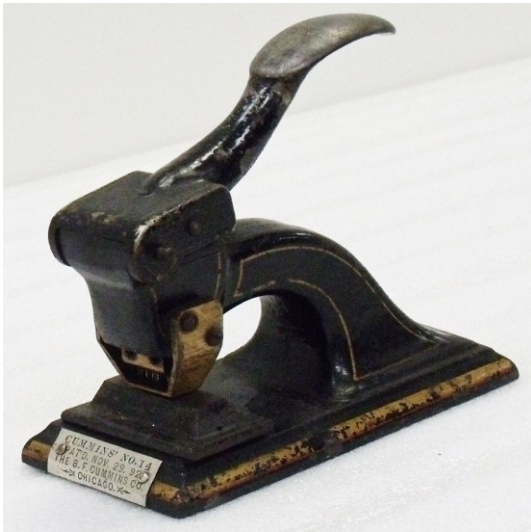
Cummins Model 14

only single die perforator known to exist is that of the Ogilvie Flour Mills Company, Winnipeg (04) which is a Cummins Model 14. The Cummins Perforator Company specifications for this machine have not been located.

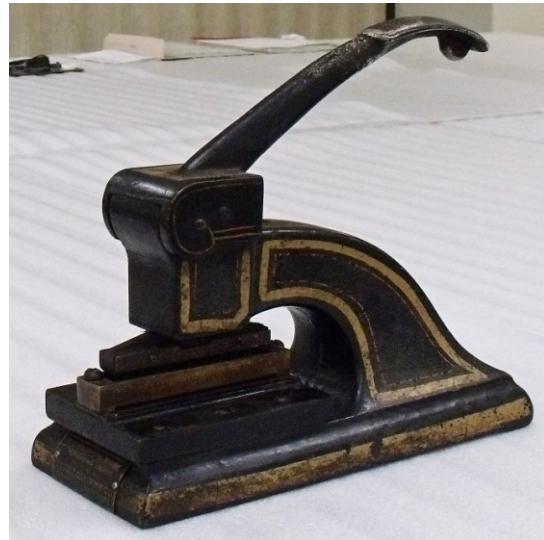
Cummins Model 52

The machine that has had the widest distribution in Canada is Model 52 from the B.F. Cummins Perforator Company of Chicago, Illinois. This machine has a width to accommodate a row of five regular sized (George V Admiral) stamps which necessitates a sheet of stamps being folded or separated in half prior to the perforating operation. These groups of pins forming the set of initials are so spaced that when one-half sheet of regular sized stamps are perforated, the design appears in the center of each stamp. It is common, therefore, to find more recent stamps with their varying sizes having split or off-center perforations and, of course, double-sized stamps will contain part of an extra set of initials, or two sets due to the width of the stamp.

Model 52 shown above has a base measuring 12½" x 5" and weighs 23 pounds. The base is made of cast iron while the balance of the machine is steel. The listed capacity by B.F. Cummins is as follows:

*Three or less initials on each stamp – four sheets thick  
(20 stamps at each stroke, row of 5)*

*Four initials on each stamp – three sheets thick  
(15 stamps at each stroke, row of 5).*

*Five or six initials on each stamp – two sheets thick  
(10 stamps at each stroke, row of 5)*

*Stamps can be perforated at the rate of 300 to 500 per minute.*

The Cummins Model 52, if a folded sheet was fed into it could produce mirror pairs with one position being the normal and the other reversed. These pairs are scarce, as they are usually separated when applied to the mail.

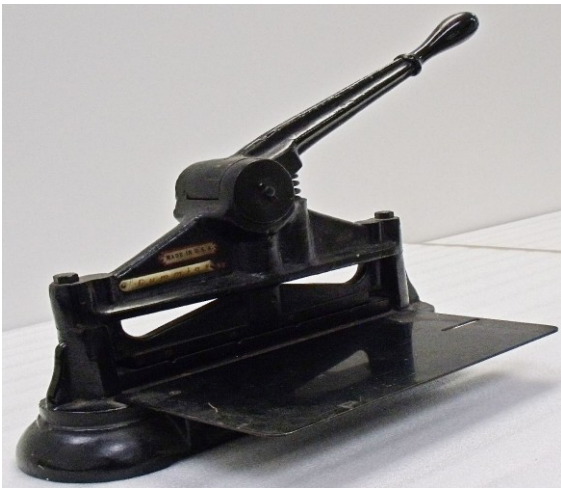
Cummins Model 53

The second most common perforator is the Cummins Model 53. This machine, shown below, has a capacity to perforate a row of 10 regular sized stamps or five large sized stamps (a common size sheet for its time) with its 10 dies. Model 53 has a base measuring 17¼" x 5" and weighs 33 pounds. With its capacity being double that of Model 52, Model 53 was used to produce many of the more common perfins.

The Cummins Model 56 is an electrically operated machine; otherwise, it is identical to Model 53. Being operated electrically and controlled by a foot pedal, the operator can perforate stamps much more quickly using Model 56. None of the Model 56 machines have been confirmed to be physically located in Canada. The only confirmed machine is that of the New York Life Insurance Company, New York City (N6), where it was still in the mail room and perforating U.S. stamps in 1985.

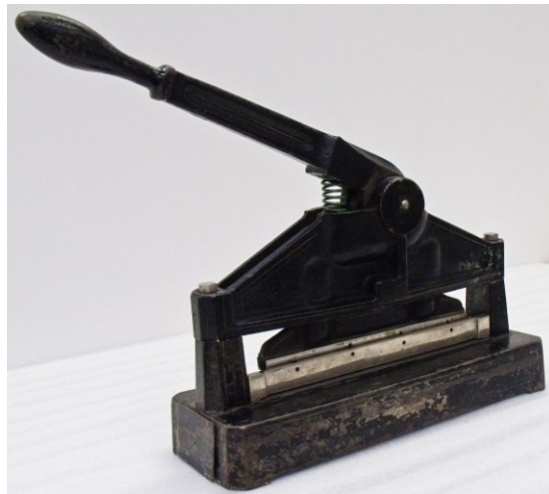
American Model 6k

To date, one American Perforator Company of Chicago, Illinois, machine is confirmed to have been used by a Canadian company. It is Model 6K and is very similar to the Cummins Model 53 both in size and capacity. It is believed that Cummins was no longer manufacturing perforators when the Canadian National Railways ordered its last perforator, (C24), from the supplier and, therefore, had to purchase the American brand perforator.
