Chapter 3

PERFORATING MACHINES

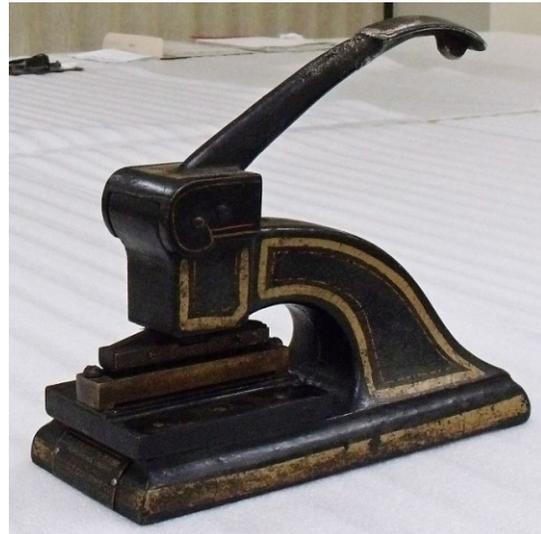
Cummins Model 52

The machine that has had the widest distribution in Canada is Model 52 from the B.F. Cummins Perforator Company of Chicago, Illinois. This machine has a width to accommodate a row of five regular sized (George V Admiral) stamps which necessitates a sheet of stamps being folded or separated in half prior to the perforating operation. These groups of pins forming the set of initials are so spaced that when one-half sheet of regular sized stamps are perforated, the design appears in the center of each stamp. It is common, therefore, to find more recent stamps with their varying sizes having split or off-center perforations and, of course, double-sized stamps will contain part of an extra set of initials, or two sets due to the width of the stamp.

Model 52 shown above has a base measuring 12½" x 5" and weighs 23 pounds. The base is made of cast iron while the balance of the machine is steel. The listed capacity by B.F. Cummins is as follows:

*Three or less initials on each stamp – four sheets thick
(20 stamps at each stroke, row of 5)*

*Four initials on each stamp – three sheets thick
(15 stamps at each stroke, row of 5).*

*Five or six initials on each stamp – two sheets thick
(10 stamps at each stroke, row of 5)*

Stamps can be perforated at the rate of 300 to 500 per minute.

The Cummins Model 52, if a folded sheet was fed into it could produce mirror pairs with one position being the normal and the other reversed. These pairs are scarce, as they are usually separated when applied to the mail.

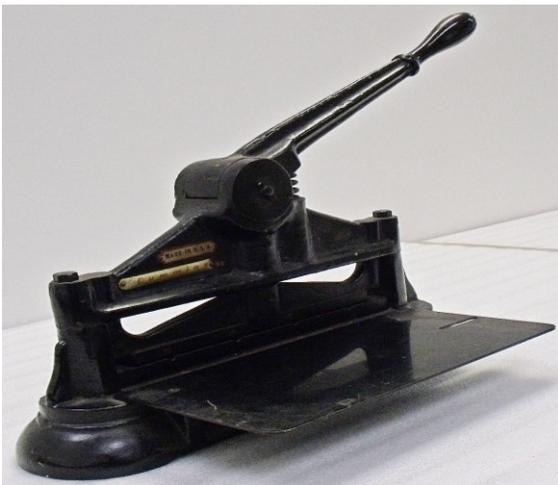
Cummins Model 53

The second most common perforator is the Cummins Model 53. This machine, shown below, has a capacity to perforate a row of 10 regular sized stamps or five large sized stamps (a common size sheet for its time) with its 10 dies. Model 53 has a base measuring 17¼" x 5" and weighs 33 pounds. With its capacity being double that of Model 52, Model 53 was used to produce many of the more common perfins.

The Cummins Model 56 is an electrically operated machine; otherwise, it is identical to Model 53. Being operated electrically and controlled by a foot pedal, the operator can perforate stamps much more quickly using Model 56. None of the Model 56 machines have been confirmed to be physically located in Canada. The only confirmed machine is that of the New York Life Insurance Company, New York City (N6), where it was still in the mail room and perforating U.S. stamps in 1985.

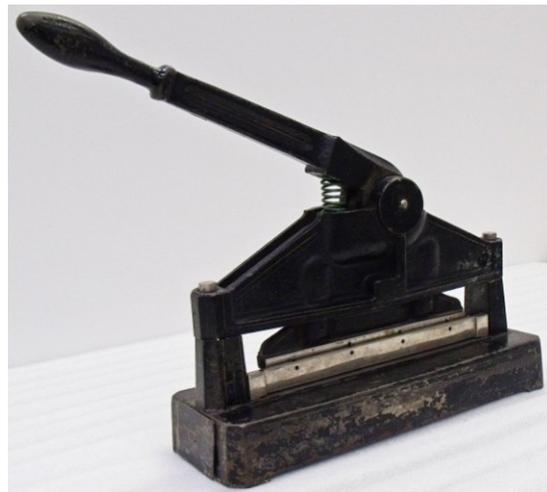
American Model 6k

To date, one American Perforator Company of Chicago, Illinois, machine is confirmed to have been used by a Canadian company. It is Model 6K and is very similar to the Cummins Model 53 both in size and capacity. It is believed that Cummins was no longer manufacturing perforators when the Canadian National Railways ordered its last perforator, (C24), from the supplier and, therefore, had to purchase the American brand perforator.
