Chapter 3

PERFORATING MACHINES

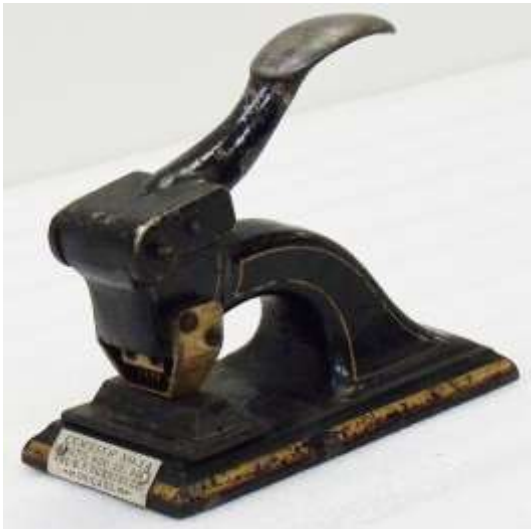
only single die perforator, manufactured in North America that is known to exist is the Cummins Model 14 operated by Ogilvie Flour Mills Company in Winnipeg (04). The Cummins Perforator Company specifications for this machine have not been located.

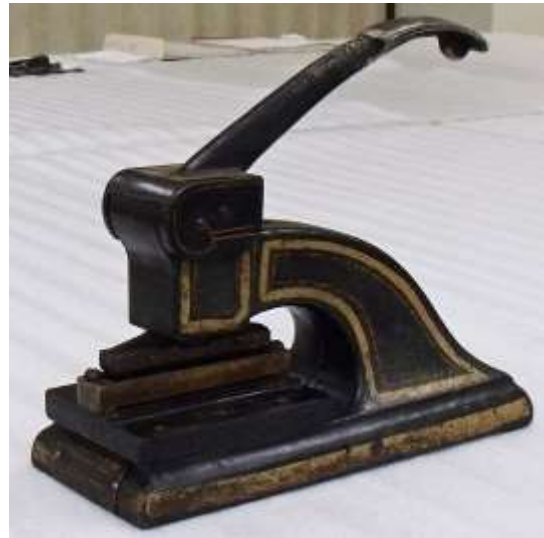
Cummins Model 52

The machine that has had the widest distribution in Canada is Model 52 from the B. F. Cummins Perforator Company of Chicago, Illinois. This machine has a width to accommodate a row of five regular sized (George V Admiral) stamps which necessitates a sheet of stamps being folded or separated in half prior to the perforating operation. These groups of pins forming the set of initials are so spaced that when one-half sheet of regular sized stamps are perforated, the design appears in the center of each stamp. It is common, therefore, to find more recent stamps with their varying sizes having split or off-center perforations and, of course, double-sized stamps will contain part of an extra set of initials, or two sets due to the width of the stamp.

Model 52 shown above has a base measuring 12½" x 5" and weighs 23 pounds. The base is made of cast iron while the balance of the machine is steel. The listed capacity by B. F. Cummins is as follows:

*Three or less initials on each stamp – four sheets thick
(20 stamps at each stroke, row of 5)*

*Four initials on each stamp – three sheets thick
(15 stamps at each stroke, row of 5).*

*Five or six initials on each stamp – two sheets thick
(10 stamps at each stroke, row of 5)*

Stamps can be perforated at the rate of 300 to 500 per minute.

The Cummins Model 52, if a folded sheet was fed into it could produce mirror pairs with one position being the normal and the other reversed. These pairs are scarce, as they are usually separated when applied to the mail.

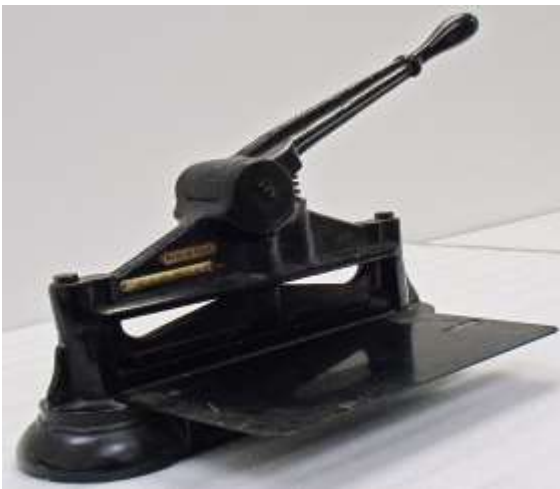
Cummins Model 53

The second most common perforator is the Cummins Model 53. This machine, shown below, has a capacity to perforate a row of 10 regular sized stamps or five large sized stamps (a common size sheet for its time) with its 10 dies. Model 53 has a base measuring 17¼" x 5" and weighs 33 pounds. With its capacity being double that of Model 52, Model 53 was used to produce many of the more common perfins.

The Cummins Model 56 is an electrically operated machine; otherwise, it is identical to Model 53. Being operated electrically and controlled by a foot pedal, the operator can perforate stamps much more quickly using Model 56. None of the Model 56 machines have been confirmed to be physically located in Canada. The only confirmed machine is that of the New York Life Insurance Company, New York City (N6), where it was still in the mail room and perforating U. S. stamps in 1985.

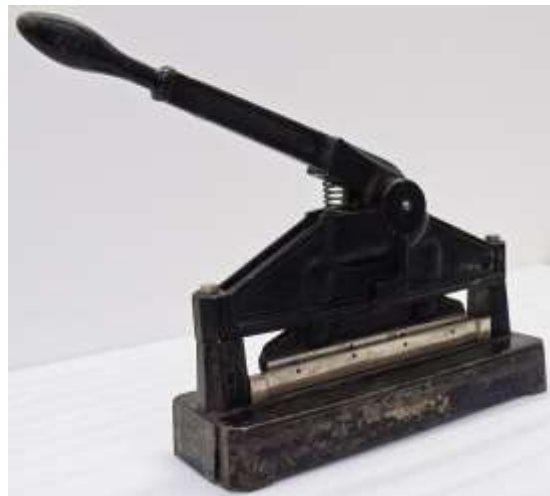
American Model 6k

To date, one American Perforator Company of Chicago, Illinois, machine is confirmed to have been used by a Canadian company. It is Model 6K and is very similar to the Cummins Model 53 both in size and capacity. It is believed that Cummins was no longer manufacturing perforators when the Canadian National Railways ordered its last perforator, (C24), from the supplier and, therefore, had to purchase the American brand perforator.
